To: Scott Fogleman, Mayor Lawrence, and Members of Town Council
From: Nicole Norman, Finance Officer
Subject: Budget Amendment Ordinance to Account for Various Items
(Ordinance #2015-17)
Date: February 9, 2016

To: Mayor JB Lawrence & Town Council
CC: Scott Fogleman
From: Parks & Recreation Director Jennifer Brown
Date: February 9, 2016
Re: Glen Burney Trail Maintenance Grant

Glen Burney Trail Assessment and Management Plan Recommendations

Glen Burney Trail Current Conditions

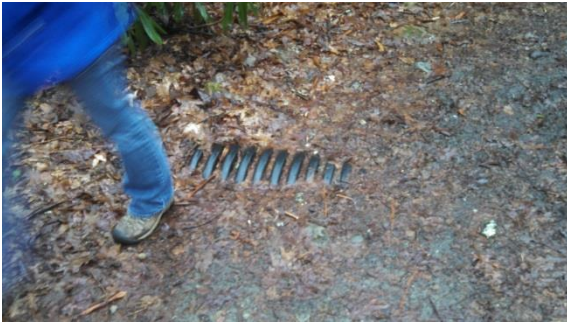
Example 1 – Failing culvert

The culvert needs to be re-surfaced over to protect the culvert and eliminate a user slip hazard. Additionally the inlet to the culvert needs to be cleaned of organic matter and a clear path of flow maintained for water running into it.

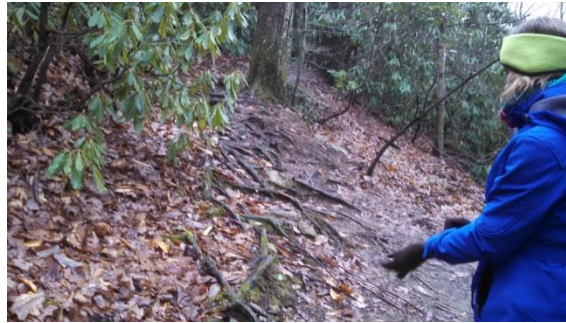
Example 2 – Indistinct tread

Exposed tripping hazard and rough ground has pushed trail users downhill causing tread creep

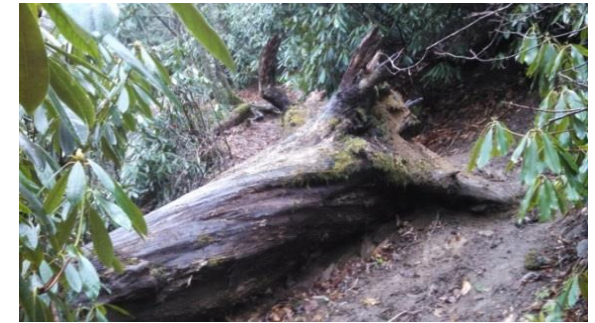
Example 3 – User based re-route

The user created re-route around this fallen tree has led to a short steep section of trail with loose soils and high erosion.

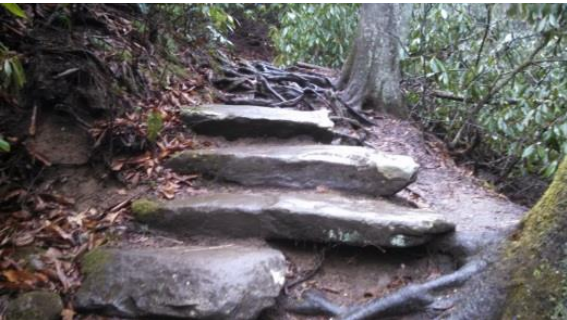
Example 4 – Failed stone stairs

Stone stairs constructed without any control structures have allowed trail users to bypass the stairs on the downhill edge leading to trail widening and erosion

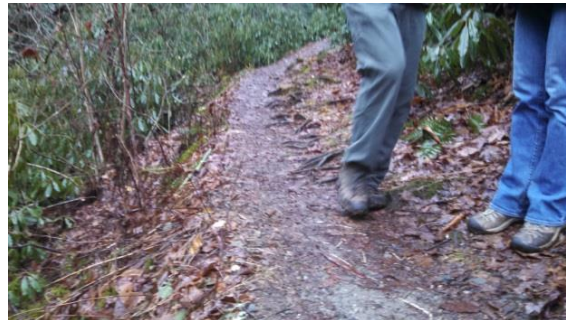
Example 5 – Tread constriction

Roots and rough terrain have pushed users to the outside edge of the established tread and narrowed the tread to 10" in some locations

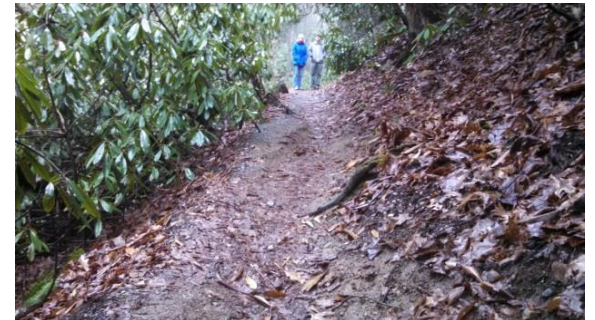
Example 6 – Drainage problems

Tread compaction have caused a berm to form on the downhill edge of the tread causing water to run down the trail, eroding tread material and further exacerbating the problem

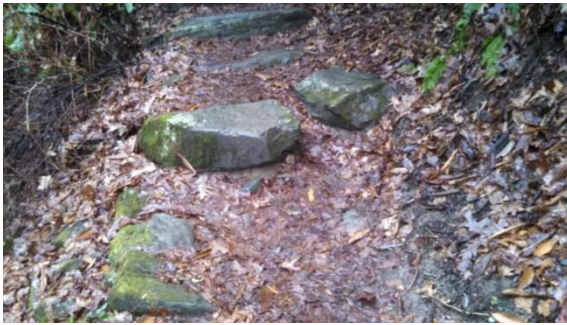
Example 7 – Failed stone structures

Stone stairs and other stone structures have failed in numerous locations due to use of undersized material in the original construction

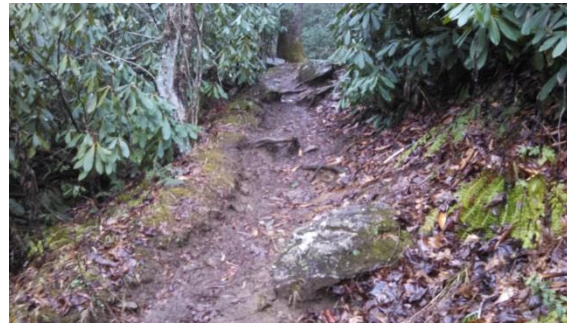
Example 8 - Erosion

Similar to example 6 erosion of the tread has caused the trail to become the path of least resistance causing a self-exacerbating problem. In numerous areas this is due solely to the fact that the trail violates the rules of 5s and/or the half rule

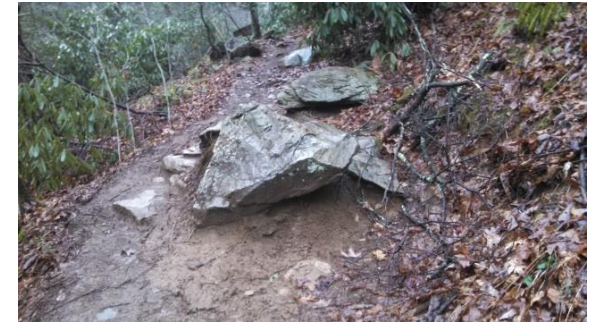
Example 9 – Original tread lost

The original tread location likely ran over the top of this stone. In a number of areas massive erosion has led to indistinct tread and former structures serving as obstacles to push people off the trail.

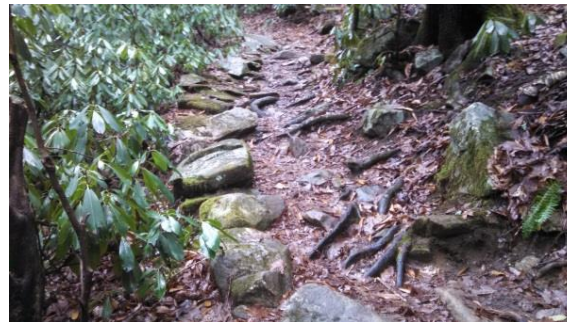
Example 11 - scouring

Here is an example of an area where the trail has lost a critical mass of soil through constant erosion over time. This scouring leaves a rough corridor that users seek a route around. 14

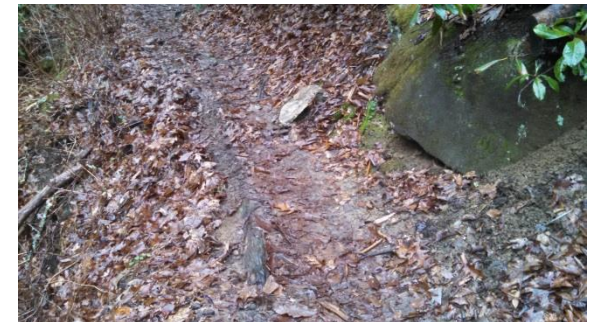
Sloughing and pinching

Steep banks down-slope from the trail are high risk areas for erosion. In numerous spots downhill stabilization will be necessary to retain the trail tread.

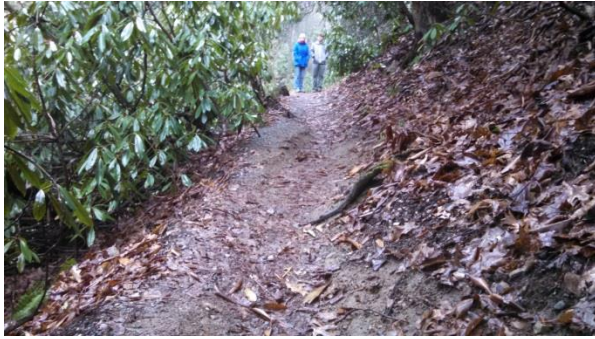
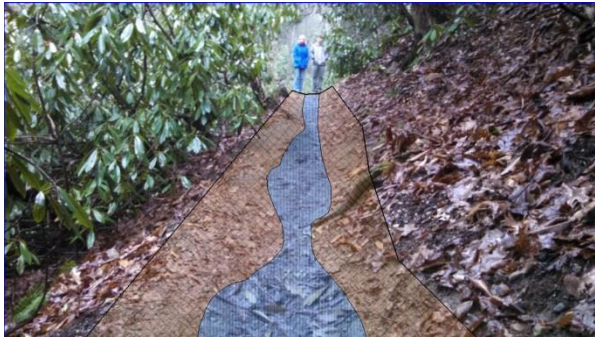
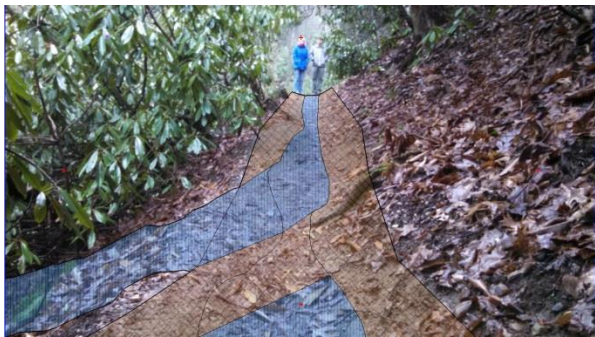
Drainage Corrections

The entire Glen Burney Trail needs drainage corrections. Causes of channelization are numerous as outlined in the photo-log above. The solution in all areas is to provide frequent and appropriately sized structures to remove water from the trail.

In this example we see the original photograph, a photograph highlighting the problem, and the problem solved by cutting through the berm on the downhill edge of the trail.

Other examples of possible solutions include water bars, check steps with drainage swales, stone armored crossings, French drains, and ditches.

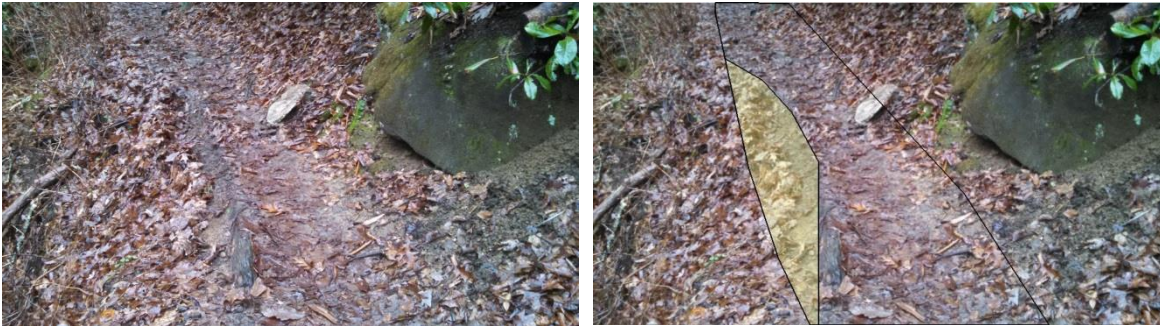
Sloughing

The Glen Burney Trail has numerous locations with very steep cross slopes. When the cross slope drops immediately off the trail tread with not shoulder it leads to sloughing of the downhill edge of the trail. This narrowed trail becomes a safety hazard for users, particularly in pinch-points such as this example where a large boulder resides on the uphill slope.

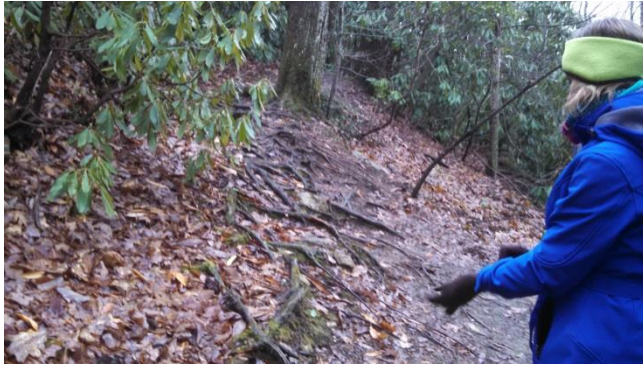
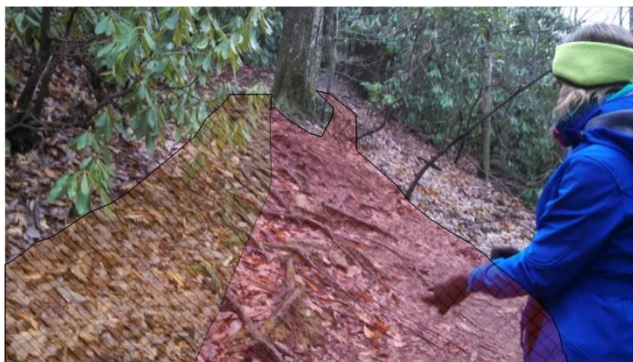
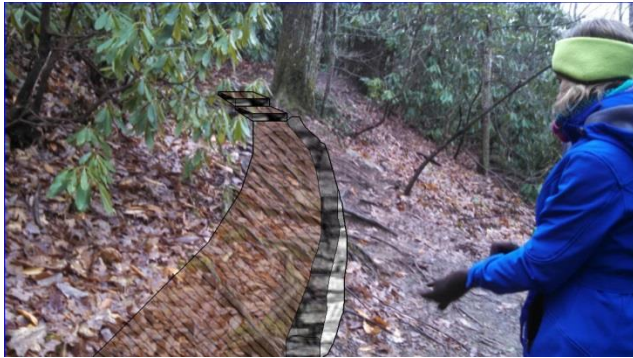
Tread Creep

Tread creep is prevalent in a number of locations along the trail but particularly bad from the top of the Glen Burney falls to the base of the Glen Marie falls. Creep originates with trail users avoiding some obstacle.

In the example provided here we see the original photograph with exposed soil on the far downhill edge of the trail corridor. In the second photo the brown cross-hatch represents the originally benched trail tread. Over time compaction and erosion led to root exposure and the tread slowly crept downhill through the red cross-hatch area.

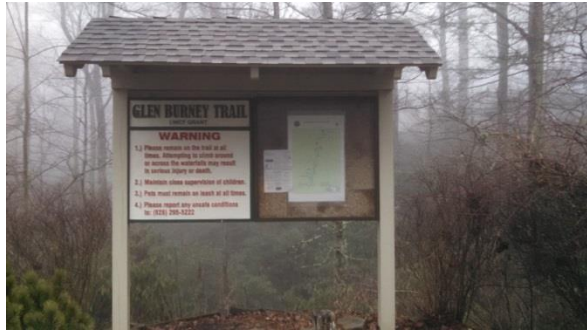
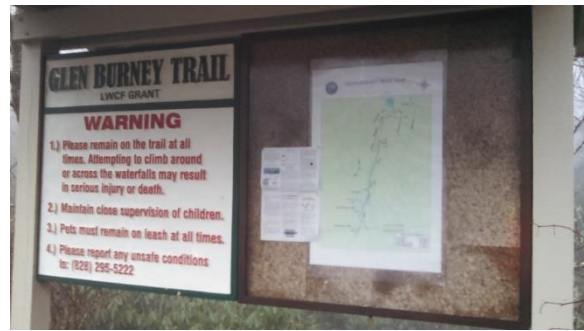
The kiosk in the parking area tells trail users of the basic regulations of trail use and warns them of the dangers of the falls. It also provides a basic trail map and supplemental information. The kiosk is well visible from the parking area but does not have to be passed by to access the Glen Burney Trail. It is recommended that the kiosk be moved in alignment with the trailhead or the trail-head access be moved to force people to walk past the kiosk.

The bulletin board section of the kiosk should also contain some enhanced permanent information about the trail that addresses the following items:

- While the hike in is relatively easy, it is a **strenuous** hike on the return trip
- Warning that this is an out and back trail only with no access to other exits
- Information about the general conditions and construction of the trail. This is particularly important as the first ¼ mile of trail are relatively flat and have a significant amount of imported materials
- A reminder to respect private land owners immediately adjacent to the trail

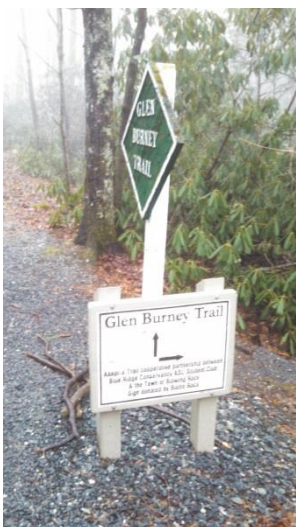
The trail name signs and individual falls signs are all nicely crafted and fitting to the aesthetic of the trail. At

the trailhead, the signs indicate variable routes users could follow.

These signs should all be re-oriented to direct users in only one

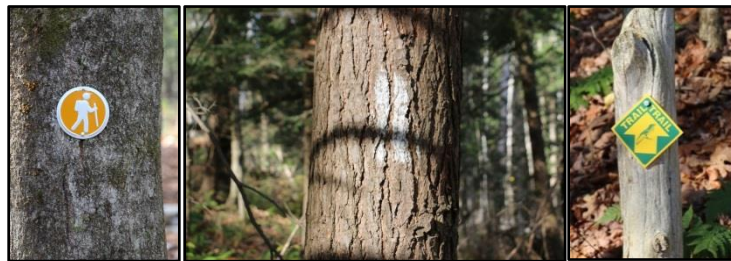
The Glen Burney Trail does not have significant blazing/reassurance signage. Blazes or other trail markers provide trail users with occasional reassurance that they are on the right path. There are a number of accounts on hiking websites and blogs where users have identified challenges following the trail corridor. This was not found to be the case during the trail survey. For the users who are having difficulty finding the trail installation of simple and unobtrusive trail blazing is recommended. Some common types of trail blazes are pictured below.

By utilizing trail blazing and implementing the recommendations in this report to re-define the trail tread there should be no confusion about the direction the trail takes. This will also limit the number of people that inadvertently walk out to private property disturbing landowners because they lose the trail corridor.

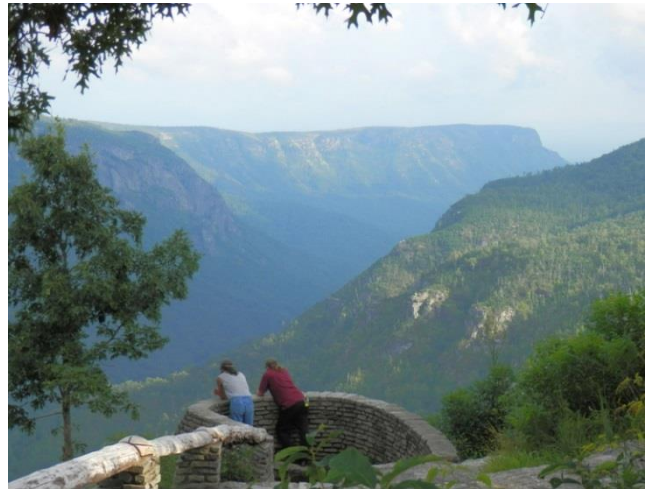
Stone walls have been used in a variety of outdoor recreational settings as a barrier to high risk areas. Stone walls have been frequently used since the 1930's when the Civilian Conservation Corps built many of the nations developed state and national park sites. As a natural building material, stone is easily incorporated into the aesthetics of the trail setting. It's longevity as a building material is unsurpassed when constructed by an experienced mason. Stone can be dry stacked, wet stacked (i.e. built with mortar) or applied as a veneer to a substructure case of concrete or formed steel. The example here is a stone wall barrier at the Linville Gorge area.

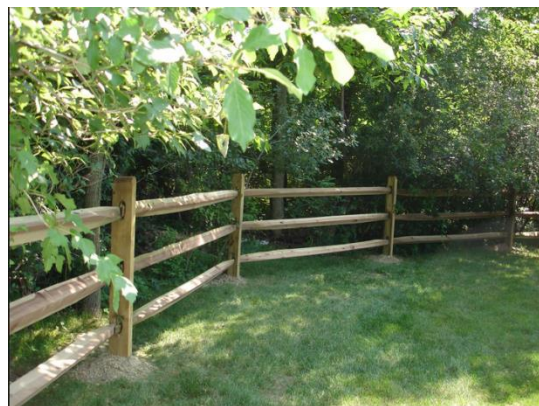
Wood comes in a variety of shapes and sizes including split rail, post and plank, post and dowel, and picket fences. The Glen Burney Trail currently has a split rail fence above the ruins and a plank fence serving as a visual barrier between the trail and a private residence. Wood is easy to install and provides flexibility in design and span. Depending on style it can also seamlessly blend into the natural landscape. Wood requires regular maintenance and inspection to ensure

that it remains sound and safe. Wood provides the least longevity of the three options outlined.

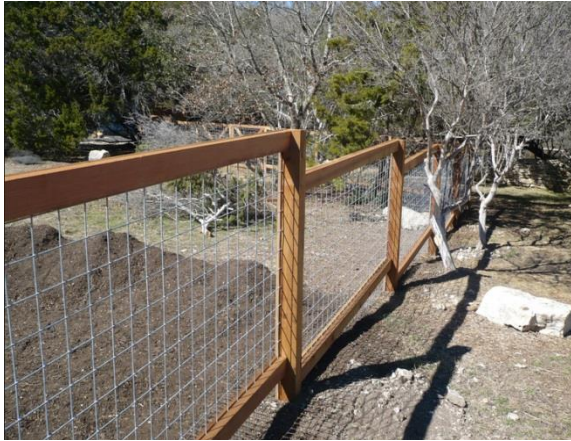
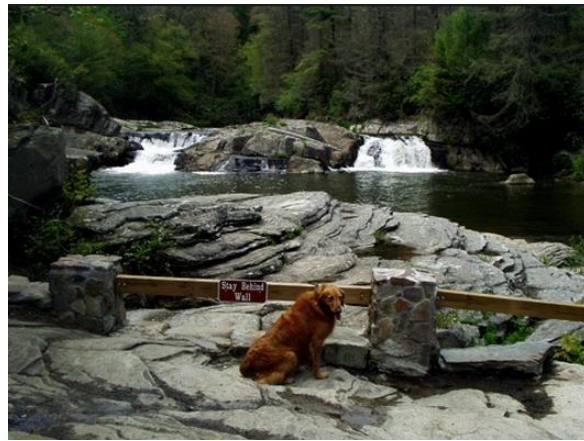
In addition to the options outlined above materials can be combined together to form a barrier that enhances their functionality while providing meeting aesthetic, safety, and longevity needs of the town. Examples below include wood-and-steel and wood-and-stone.

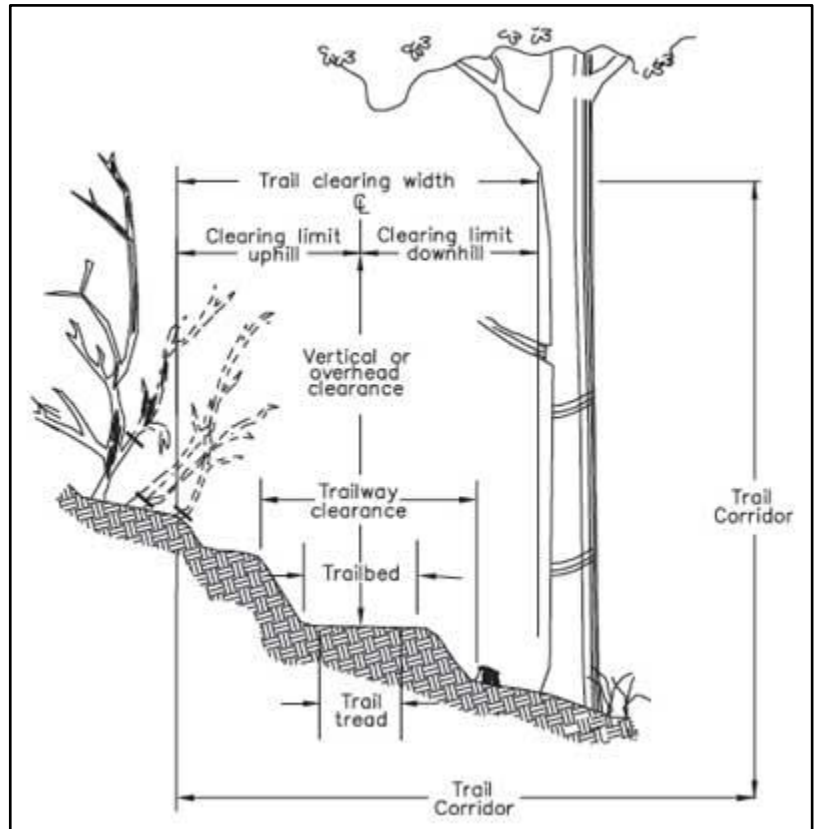
Corridor Clearing - Each trail type and class has a designated trail corridor that should be established and maintained. To create a good mental picture, a corridor can be thought of as a tunnel through the undergrowth. Establishing a well defined and comfortable trail corridor is the first step in keeping users on the established trail. Annual maintenance on the trail corridor includes clipping any new growth extending into the corridor, pruning any branches that have bent into the corridor over time, trimming back shrubs and other low lying plants that are encroaching on the treadway, and regular mowing and/or brush hogging of grass paths and trails in open meadow areas where full sun access allows for quick vegetative growth.

Visual example of trail corridor and terminology (Hancock, 2007)

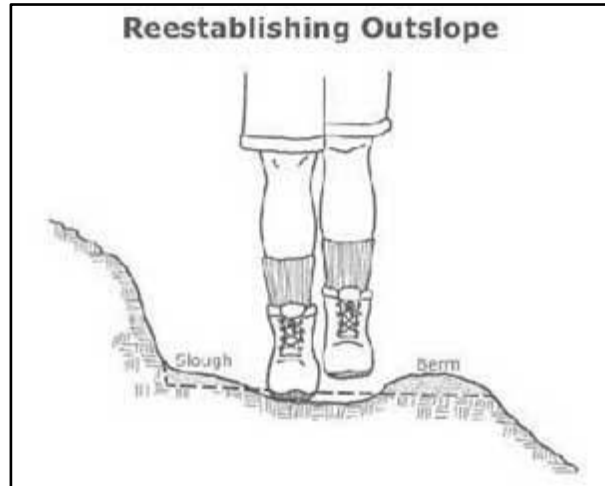
Annual Drainage Clean-outs - Trail drainage structures include culverts, water bars, grade dips, nicks, cross drains, and ditches among others. There are many names used in the trail world so the easiest way to think about drainage structures is to ask the question: *does this allow water to get off the trail?* If the answer is yes then it deserves annual maintenance. Annual drainage clean-outs should be completed in the autumn after leaf-fall. This will allow the trail system to be ready to handle the spring melt-off. All drainage structures should be fully cleared of leaves, sticks, rocks, and other debris that has made its way into the drainage over the course of the year. This allows a drainage structure to efficiently move water away from the trail tread. On sites with highly erodible soils a thin vegetative layer can be reapplied to a drainage structure to help prevent impact erosion during rain storms. This can be accomplished by sprinkling a thin layer of leaves over the cleared area.

Visual of slough and berm (Hesselbarth, 2007)

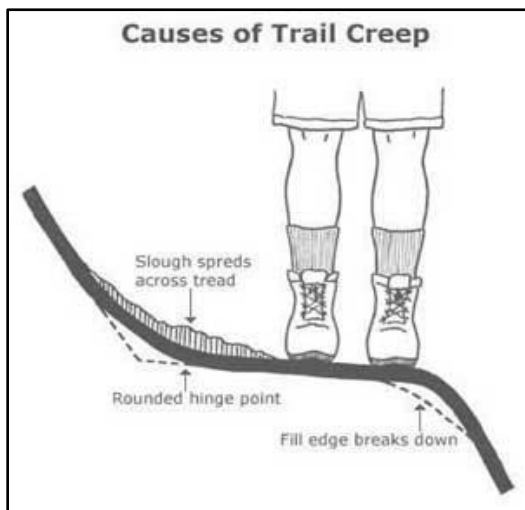
Tread Corrections – The trail tread-way is the main foundation of the trail and the focused impact point by trail users. This impact can cause subtle soil movement over time that can lead to major problems on a trail system. Two common impact problems that develop over time are trail creep and berm build-up. See images two and three. Annual tread maintenance should consist of removing the slough and berm that develop over time to maintain adequate cross trail drainage. When conducted on an annual basis this work can be completed with a light duty hand tool such as a McLeod, square shovel, or a garden hoe. Once a slough or berm has been allowed to establish heavier hand tools such as a pick mattock may be needed.

Visual of trail tread creep (Hesselbarth, 2007)
